INSPECTION REPORT

QINGDAO STARCO CHEMICAL CO.,LTD PRINCIPAL:

GOODS DESCRIPTION AS Urea PROVIDED BY CLIENT:

SCOPE OF WORK: Visual Check Cargo Condition

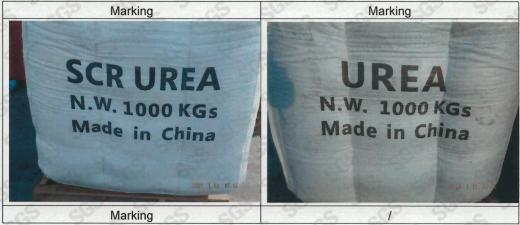
Marking was found to be printed and attached on the bags with declared Batch No. 20230115 during the inspection as far as accessible and visible, detailed photos please refer to below.
